Technical Memorandum

Title: DEVELOPMENT AND TESTING OF ELCAS RO/RO

Author: PATRICK R. KANE and BILLY R. KARRH

Date: JANUARY 1991

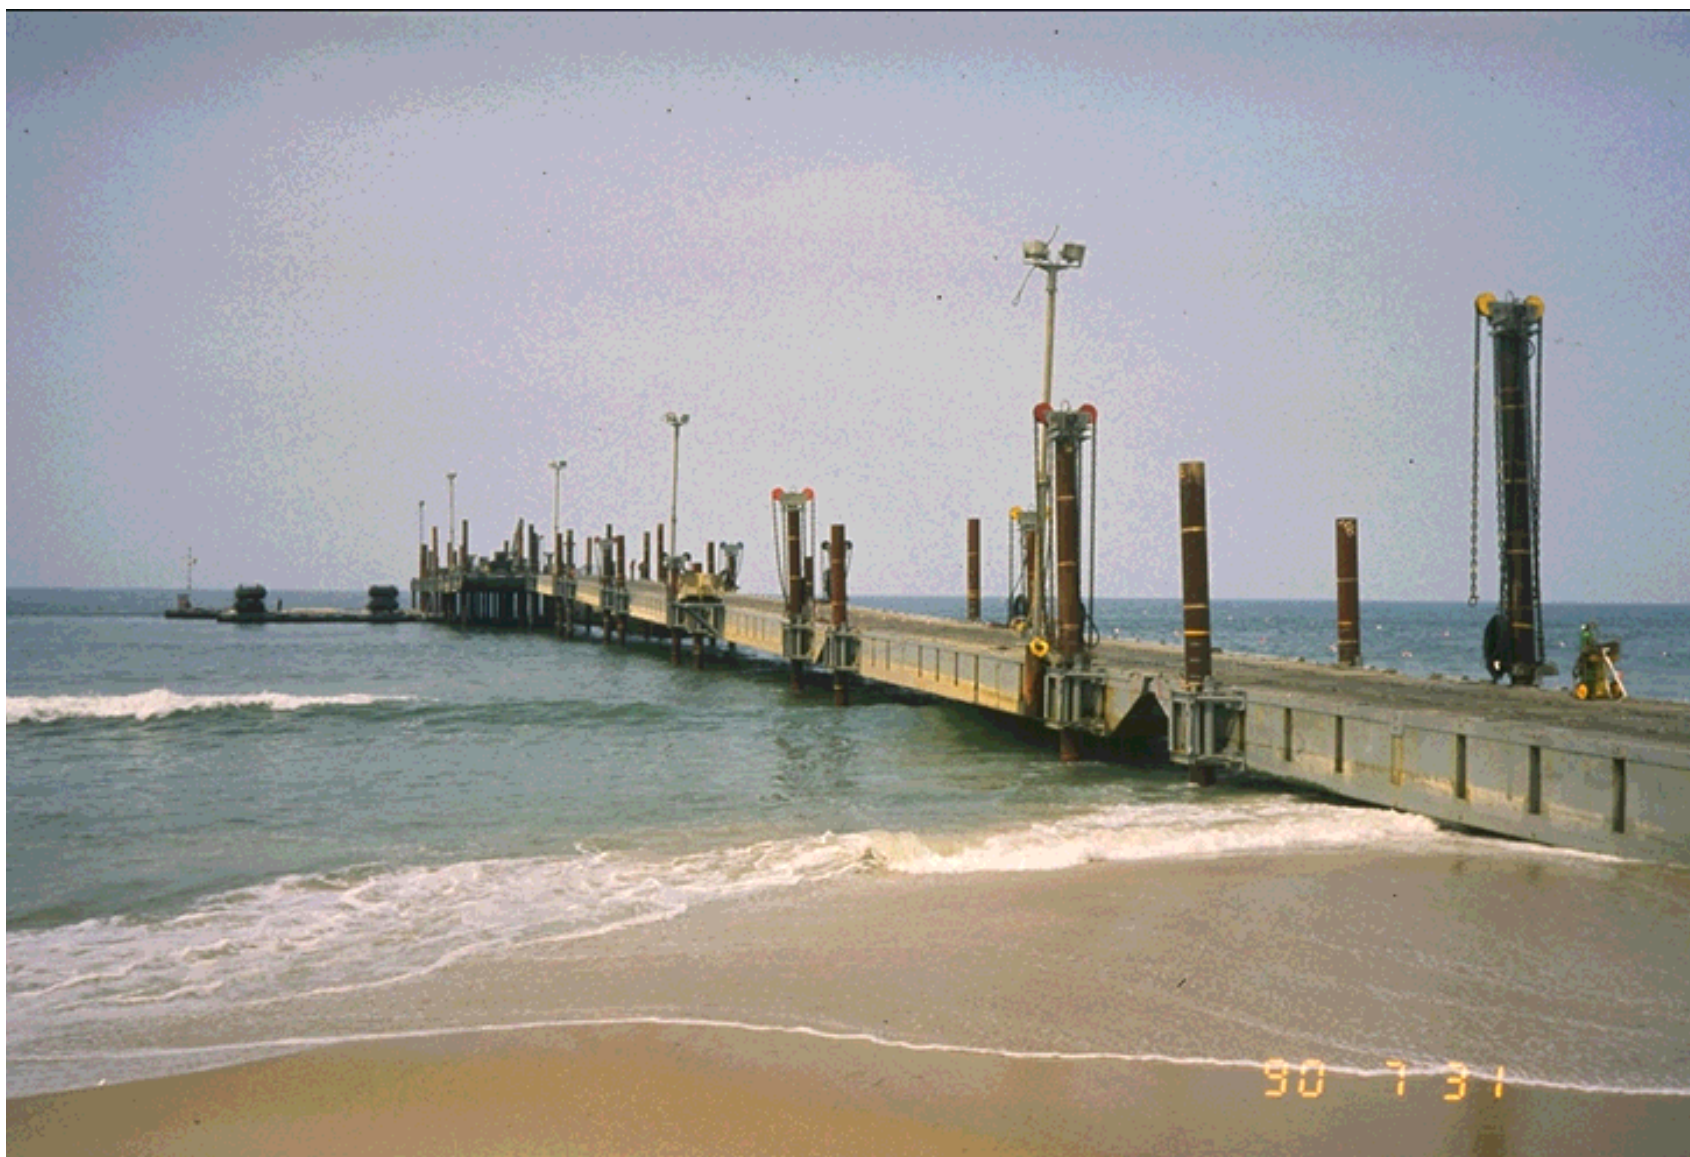
Figure 19. ELCAS Installation (NCEL Photo 2434-90)

Phase II testing coincided with an ELCAS installation in July/August 1990 at Fort Story, Virginia (Figure 19). The PHIBCB's installed a thirteenth section to the standard twelve section ELCAS because a three section wide ELCAS pierhead was required for the ELCAS RO/RO concept. Pile guides were welded on top of the shear connectors on each outboard pierhead section (Figure 20). Four sacrificial 20" diameter pile were driven through each pile guide and served as a reaction surface to the RO/RO fenders mounted on the CPF. The LMMSA/ELCAS foundation beam was welded on top of the shear connectors of the center pierhead section (Figure 21).

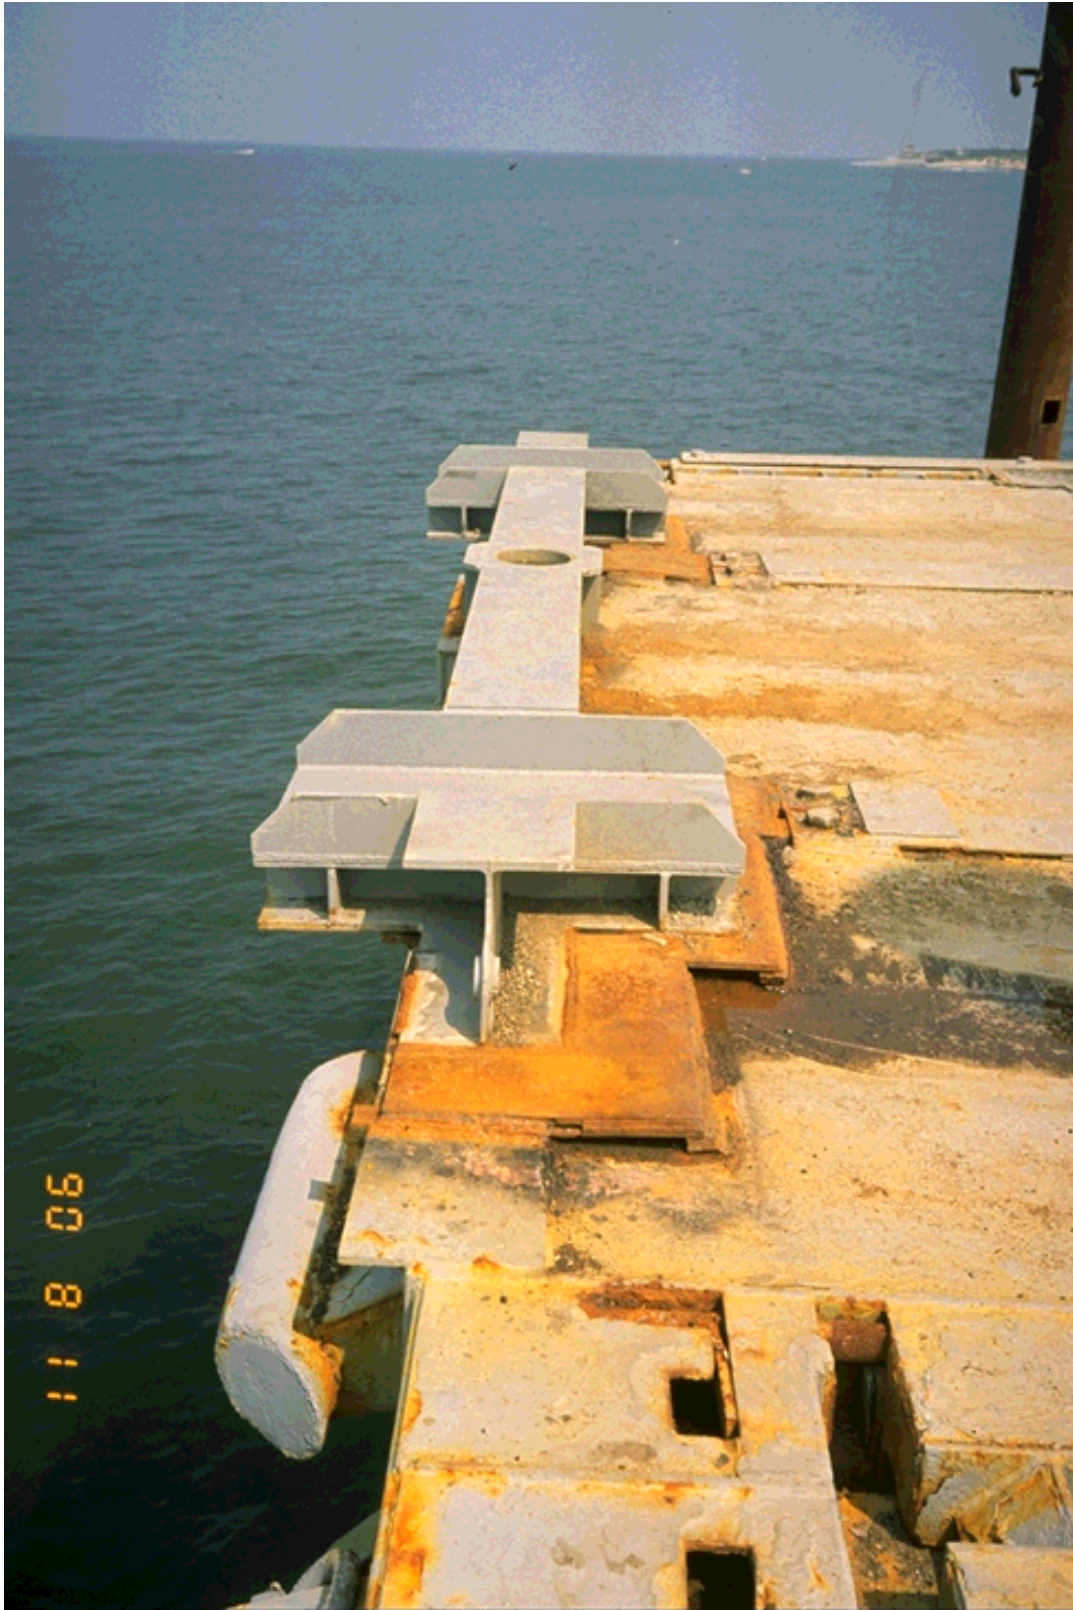
Figure 21. LMMSA/ELCAS Foundation Beam on ELCAS (NCEL Photo 2428-90)

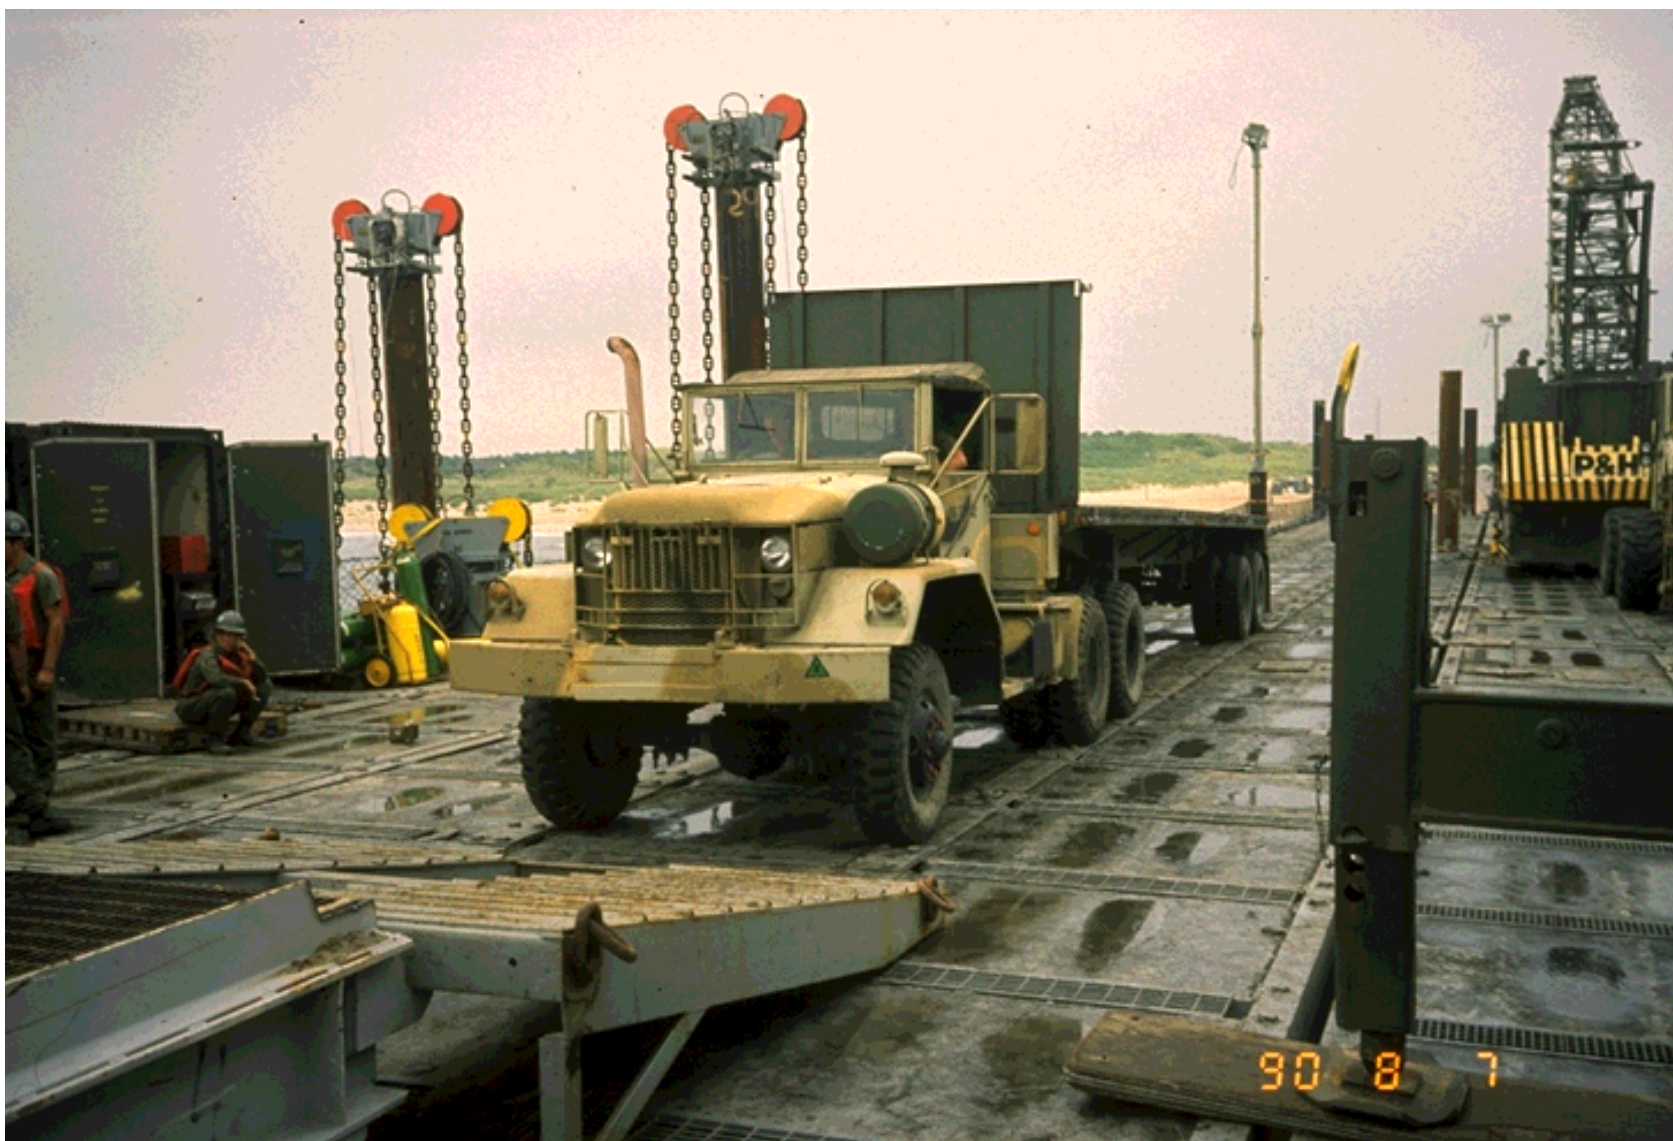
Figure 33. Tractor-Trailer Approaching LMMSA/ELCAS Interface (NCEL Photo 2474-90)

ELCAS toward the LMMSA. At the pierhead it climbed the turntable and beach ramp, then traveled down the LMMSA onto the CPF deck (Figures 33 through 36). There were no interference problems for the tractor-trailer in traversing the dual ramp transition from LMMSA to the ELCAS pierhead deck.

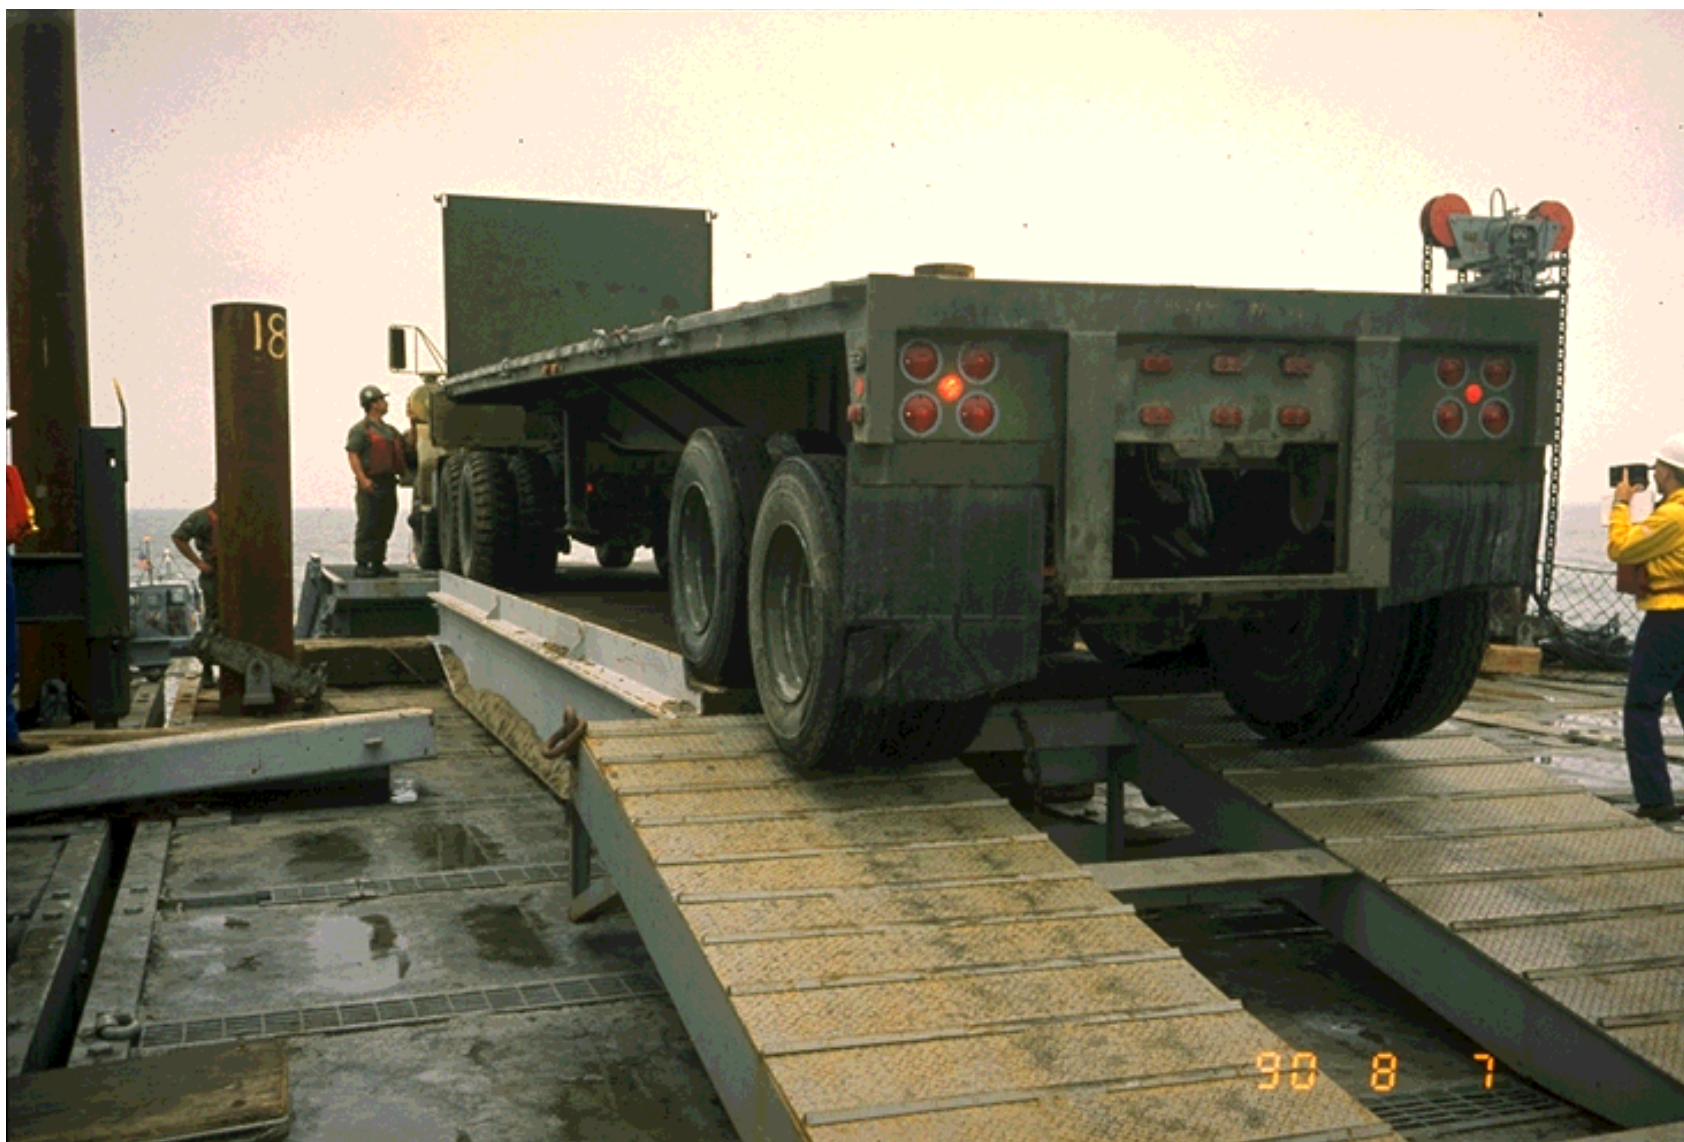
Figure 34. Tractor-Trailer Crossing Turntable and Beach Ramps (NCEL Photo 2471-90)

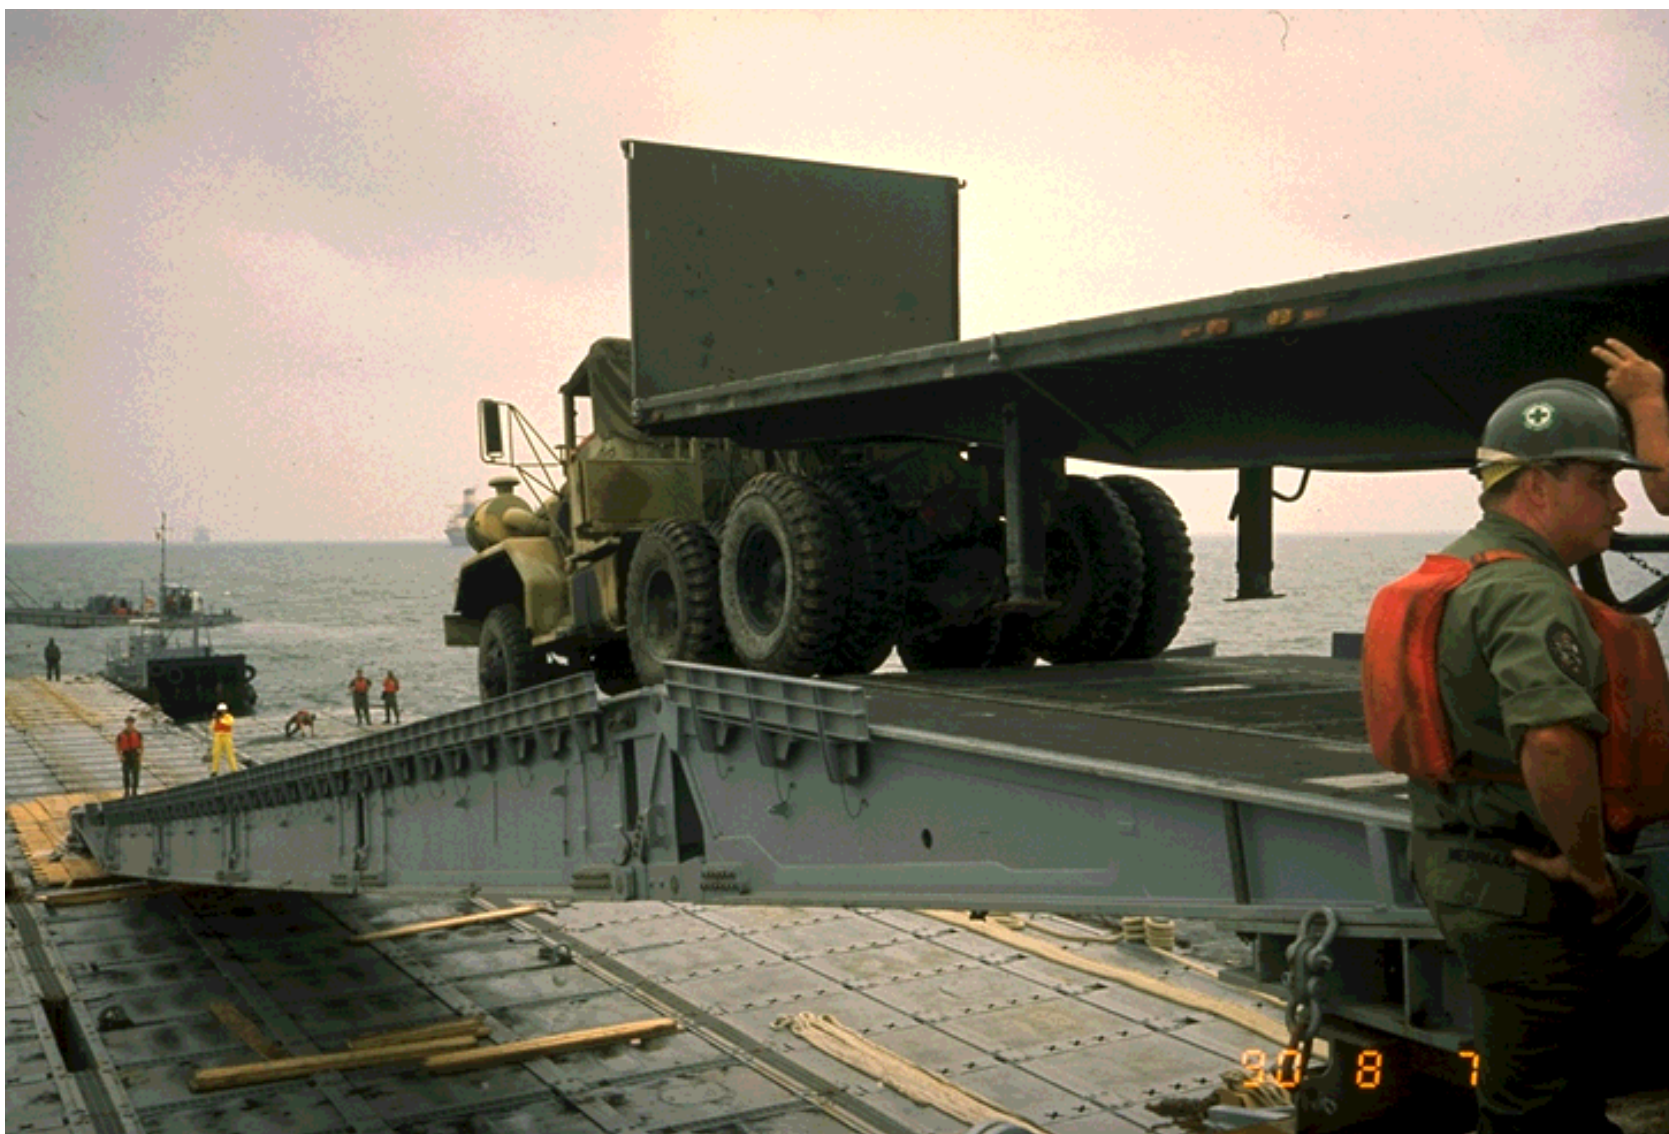
Figure 35. Tractor-Trailer Descending LMMSA Ramp (NCEL Photo 2469-90)

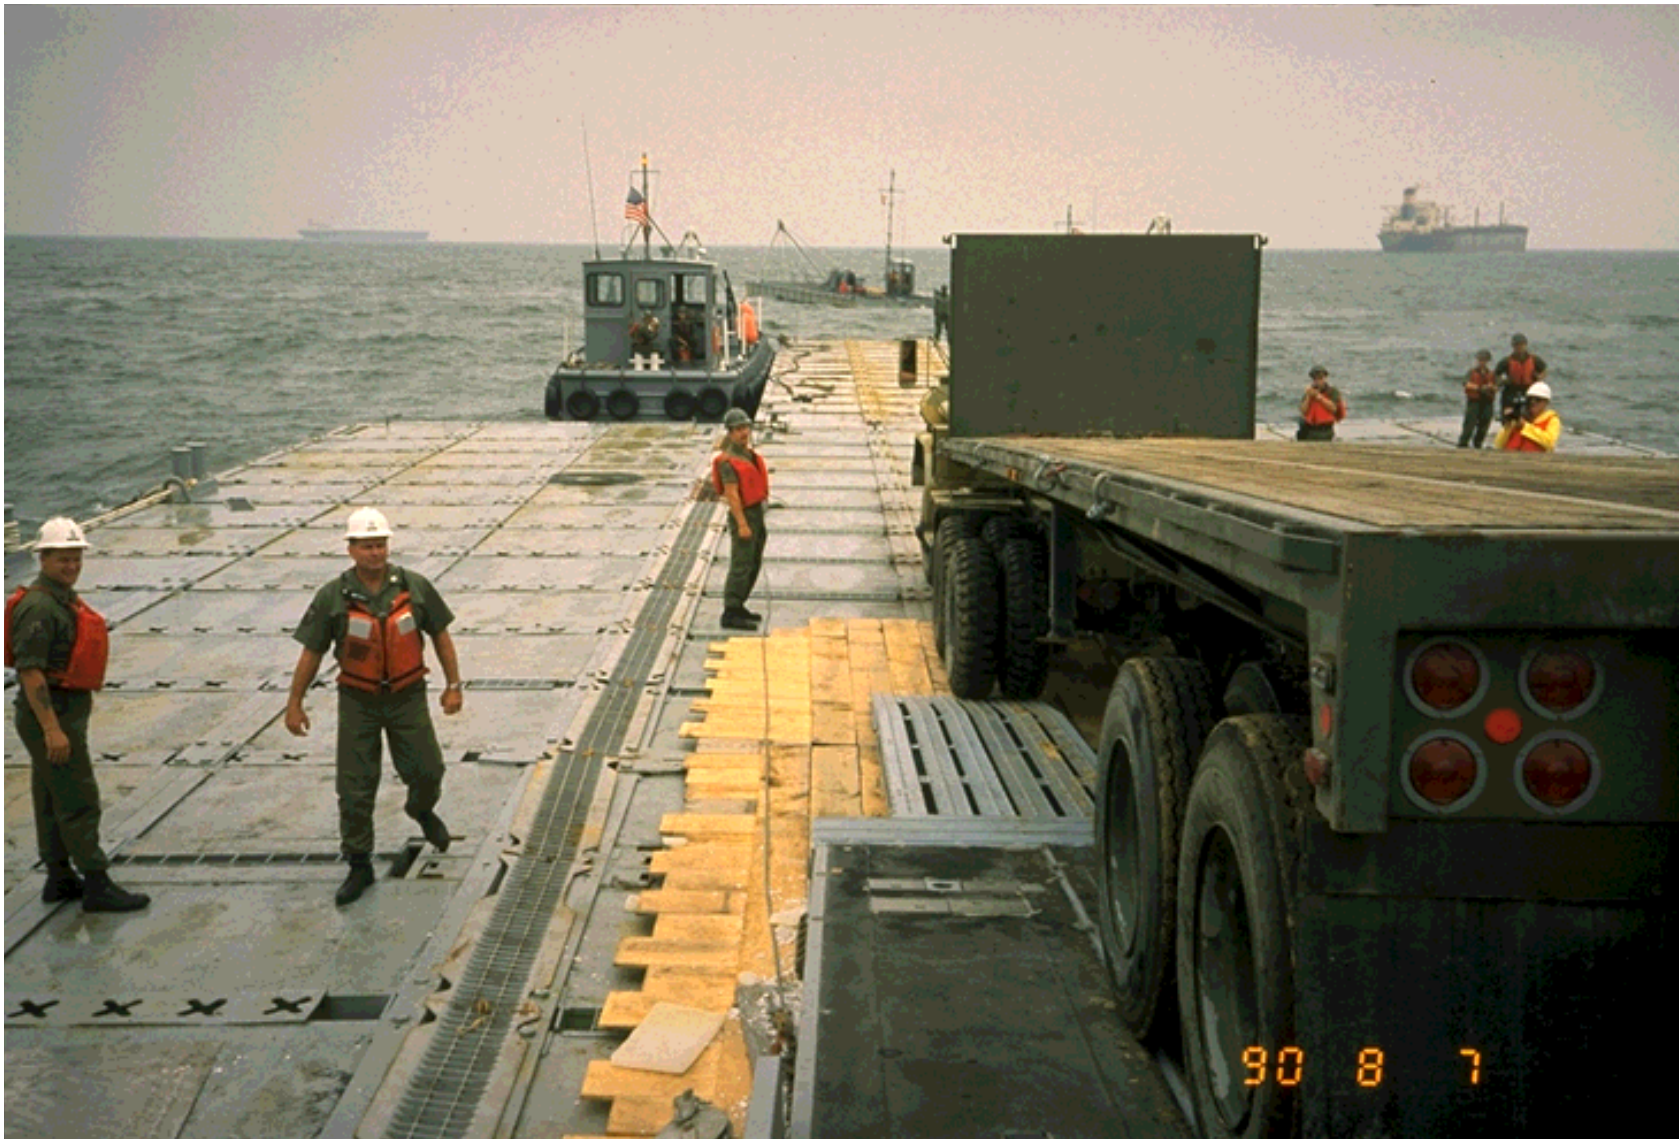
Figure 36. Tractor-Trailer Crossing LMMSA/CPF Interface (NCEL Photo 2466-90)

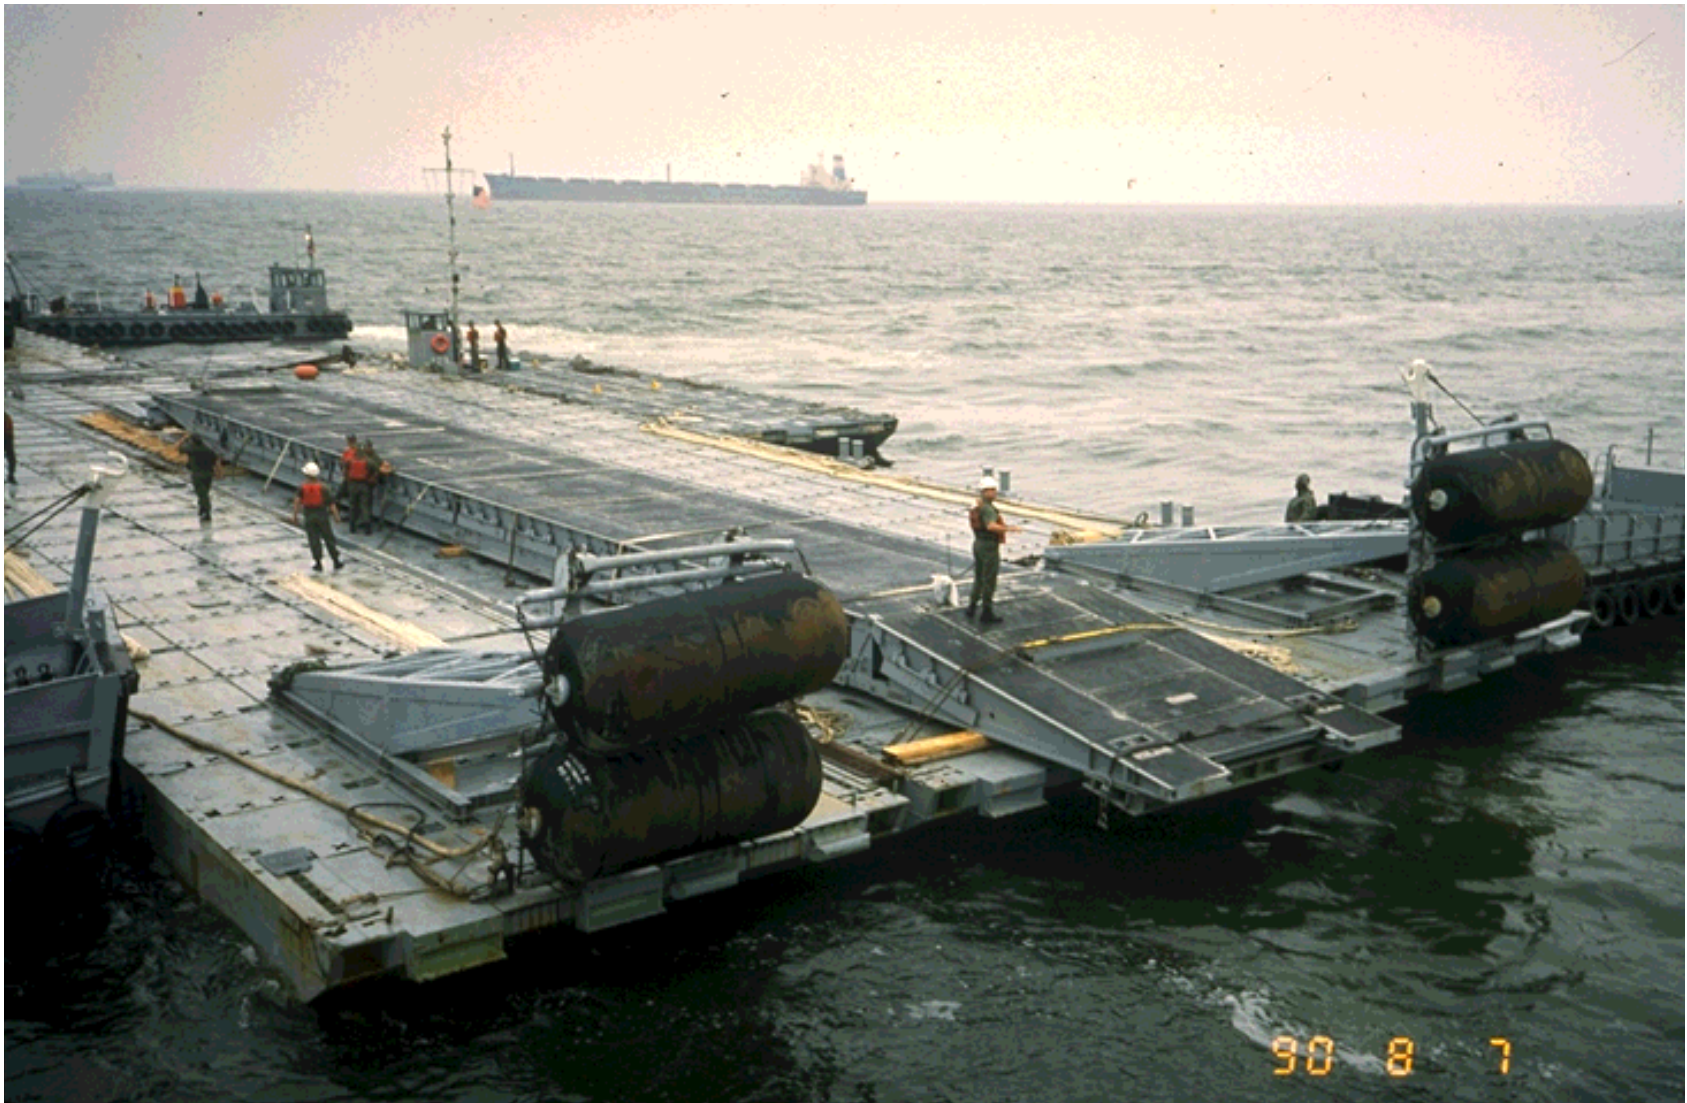
Figure 37. CPF Departing ELCAS (NCEL Photo 2464-90)
